Assessment of Dam Safety of Coal Combustion Surface Impoundments

Indianapolis Power & Light Company

Harding Street Generating Station

November 15, 2010

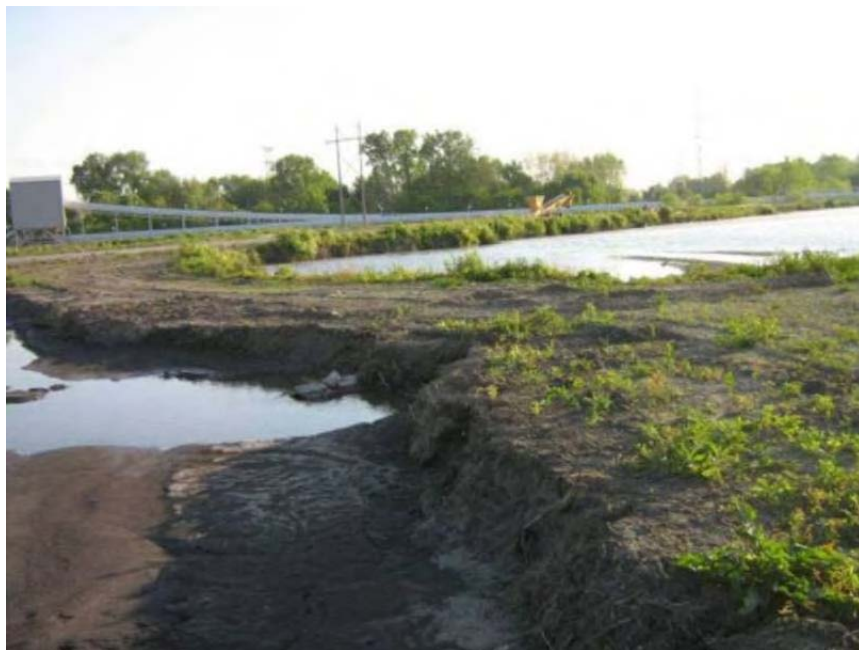
150. Ash Pond 4A - Erosion along South Embankment Interior
Slope, Looking East

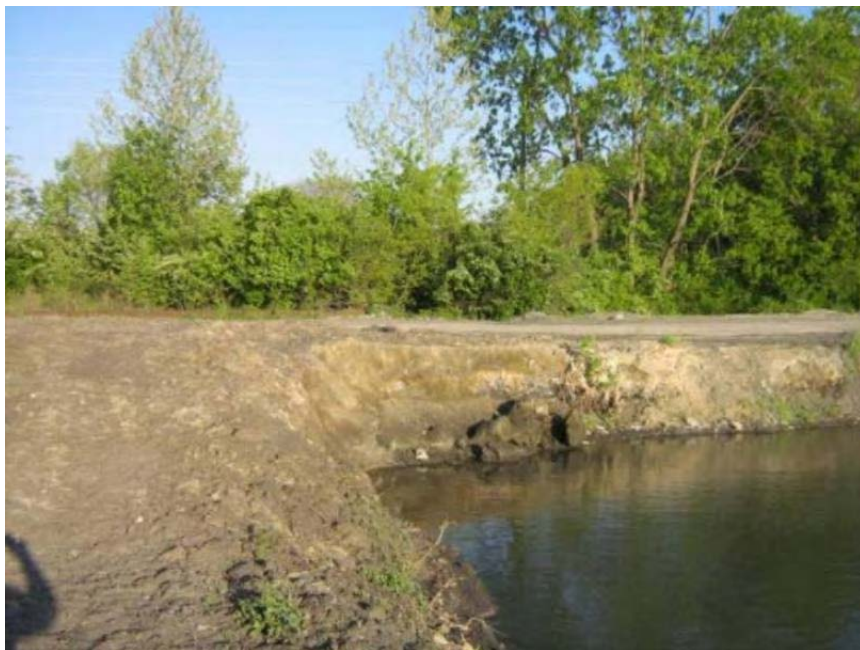
152. Ash Pond 4A - West Embankment Interior Slope, Looking West

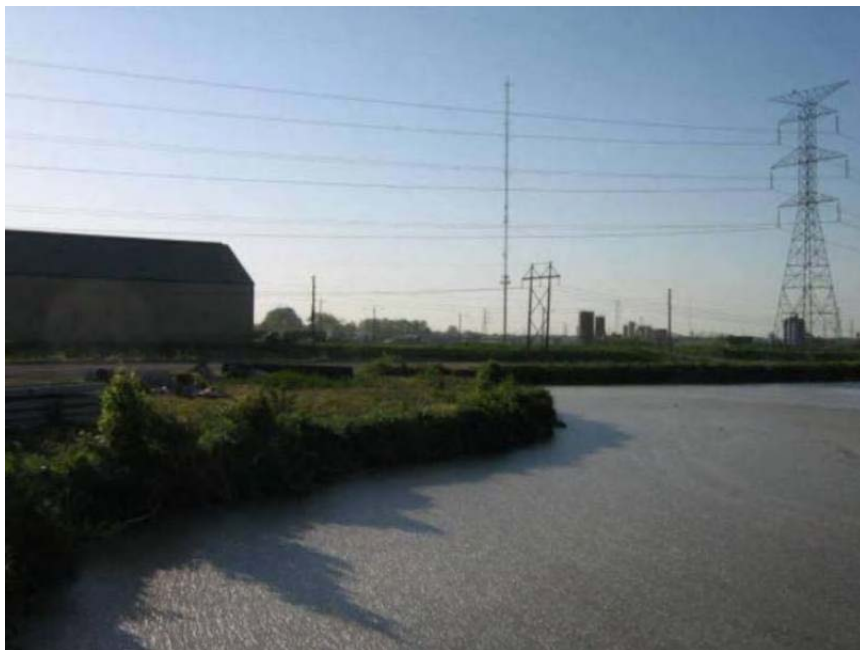
159. Ash Pond 4B - East Embankment Interior Slope, Looking South

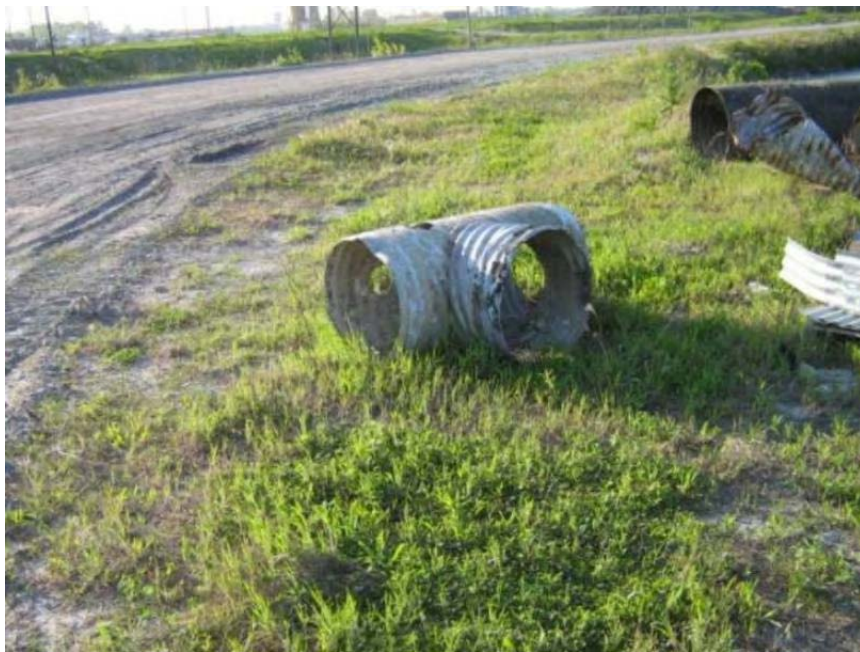
161. Ash Pond 4B - Tee-Joint, Typical of Pond Outlets

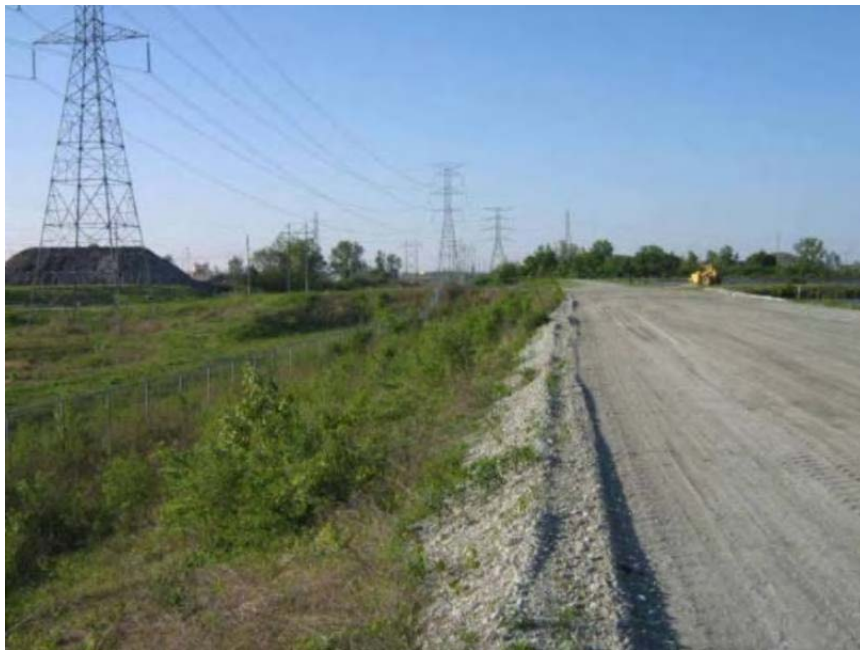
163. Ash Pond 4B - East Embankment Exterior Slope, Looking South

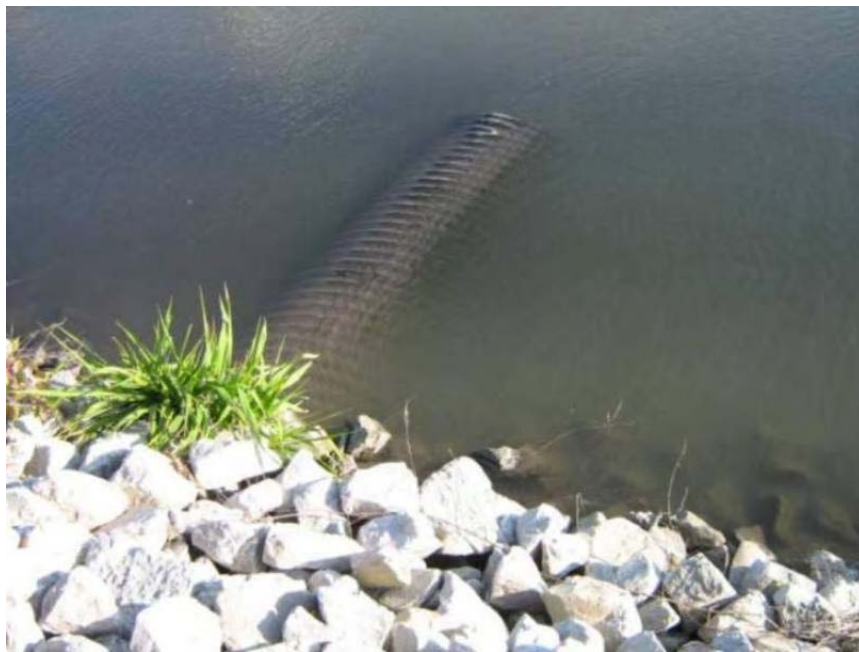
165. Ash Pond 4B - High Inlet from Ash Pond 4, Low Inlet is approximately 5 feet West, Both Inlets are 30-inch-Diameter CMP's
